GENERAL INFORMATION

Report prepared by Mark Oerther Associates, Inc. Kentucky License # HI-2045
Office (502) 459-1446 Fax (502) 345-3733

DATE OF INSPECTION: 12-21-04.
TIME OF INSPECTION: 8:30 A.M.
CLIENT NAME: Joseph Sample.
INSPECTION LOCATION: 825 Sample Road Louisville, Kentucky 40200.

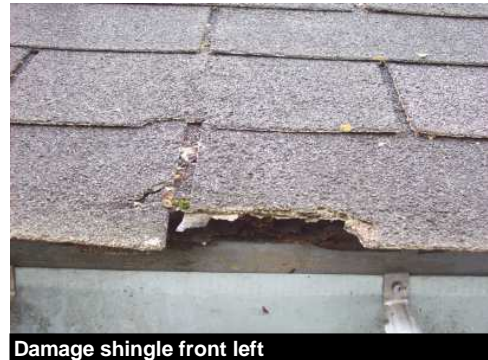
Damage shingle front left

ROOF MATERIAL: **TYPE-** shingle.
 Number of layers- One,
 Method of Inspection- Roof was walked upon.
OBSERVATIONS- There are two different ages of shingles. There is some discoloration of the shingles due to mold / fungi. The original shingles are showing some aging. There is some granular loss visible on the shingles. The shingles over the kitchen are newer. There has been multiple patched areas. There are a couple of damaged shingles at the front roof at the gutter line. This has caused some drip back / deterioration of small area of roof sheeting. No drip edge was used. There is an unrepaired nail pop at one area. **It is recommend that a qualified roofing contractor repair as needed.**

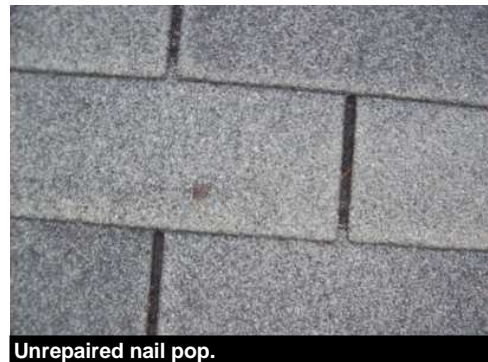
Unrepaired nail pop.

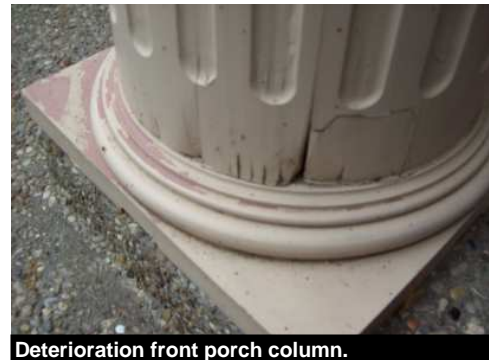
EXTERIOR SURFACES: Type- Brick, Stone / synthetic stone,
 Wood siding,
 Exterior trim type - Wood,
OBSERVATIONS- Step cracking is noted in the brick / mortar rear right side. This cracking does not effect the overall structure of the house. The wood siding has pulled out some.
Renail as needed.
Deterioration is noted at the bottom of the right front porch column.
Repair or replace as needed.

There are no weep holes visible brick mortar. Weep holes are intended to allow moisture out from behind the brick.
There is some deterioration at the wood trim of one of the built in gable vent. Replace as needed.

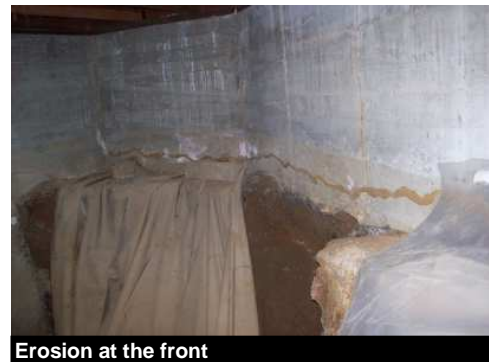
NOTE: There is erosion at the front of the house at the foundation. **Steps need to be taken to insure that no additional erosion occurs or it may cause loosening of the soil below the foundation.**

Erosion at the front

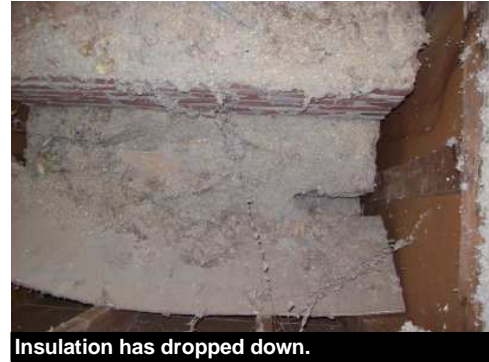
INSULATION DEPTH: The depth varies from 3" to 7". Most of the insulation is at about 6". **The insulation has dropped down near the original fireplace. Reinsulate as needed.**

Insulation has dropped down.

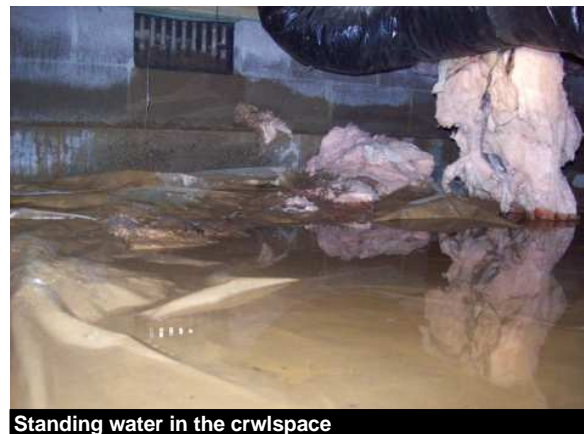
Standing water in the crawl space

There is heavy moisture under the vapor barrier. There are areas where there is mud on top of the vapor barrier that indicates water intrusion. There is standing water visible in the crawl space under the master bath / bedroom area. There are areas where moisture has been entering at the top of the concrete foundation and through the block foundation. Steps should be taken to correct as needed; consult qualified contractor about correcting the water and moisture issues. After the water corrections have been made, a proper inspection of this crawlspace area should be made.

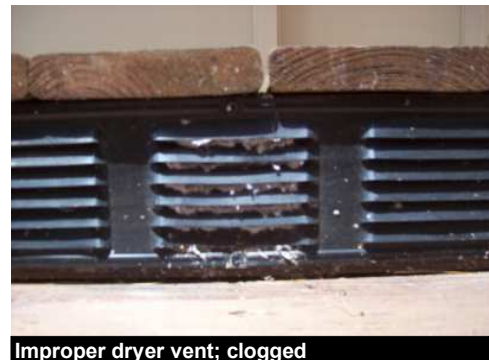
| DRYER: | Dryer supply: electric. Dryer Vent: The dryer vents to the outside. The vent pipe is dented. This restricts air flow. There is a screw through the vent pipe. This will cause the lint to catch on the screw. There is an improper cover at the exterior steps where the dryer vents. This vent is clogged. Correction is needed. |

Improper dryer vent; clogged

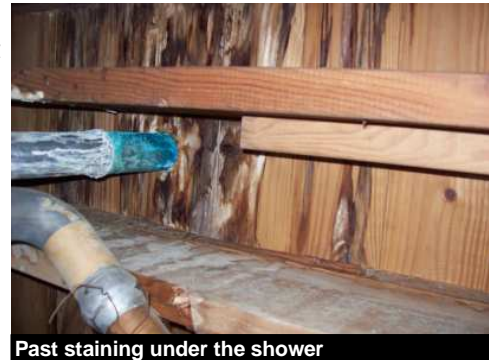
BATH LOCATION: Front right bedroom.
SINK OBSERVATIONS: Components serviceable, with normal aging.
TOILET/BIDET OBSERVATIONS: Components serviceable, with normal aging.
SHOWER OBSERVATIONS: Components serviceable, with normal aging.
SHOWER ENCLOSURE OBSERVATIONS: Shower wall and floor areas appear serviceable. There is evidence of past leakage under this shower. **Further evaluation is recommended.**

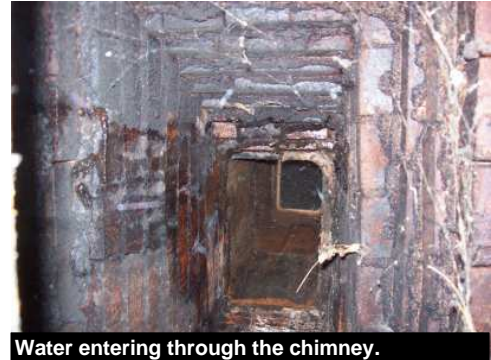
FIREBOX: Serviceable.
There is water coming down through the upper part of the chimney. Recommend correction as needed.

Water entering through the chimney.

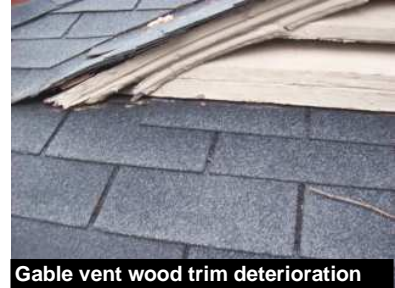
Gable vent wood trim deterioration

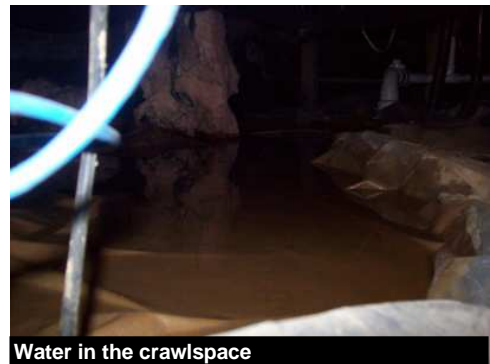
Water in the crawlspace

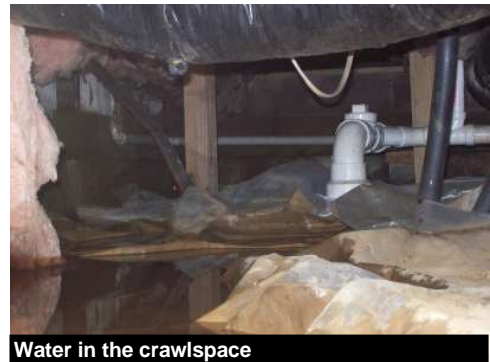
Water in the crawlspace
